US Route 7 / VT 104A Intersection and VT104A Bridge No. B1 over Arrow head Mountain Lake

In the Town of Georgia, Vermont

Table of Contents

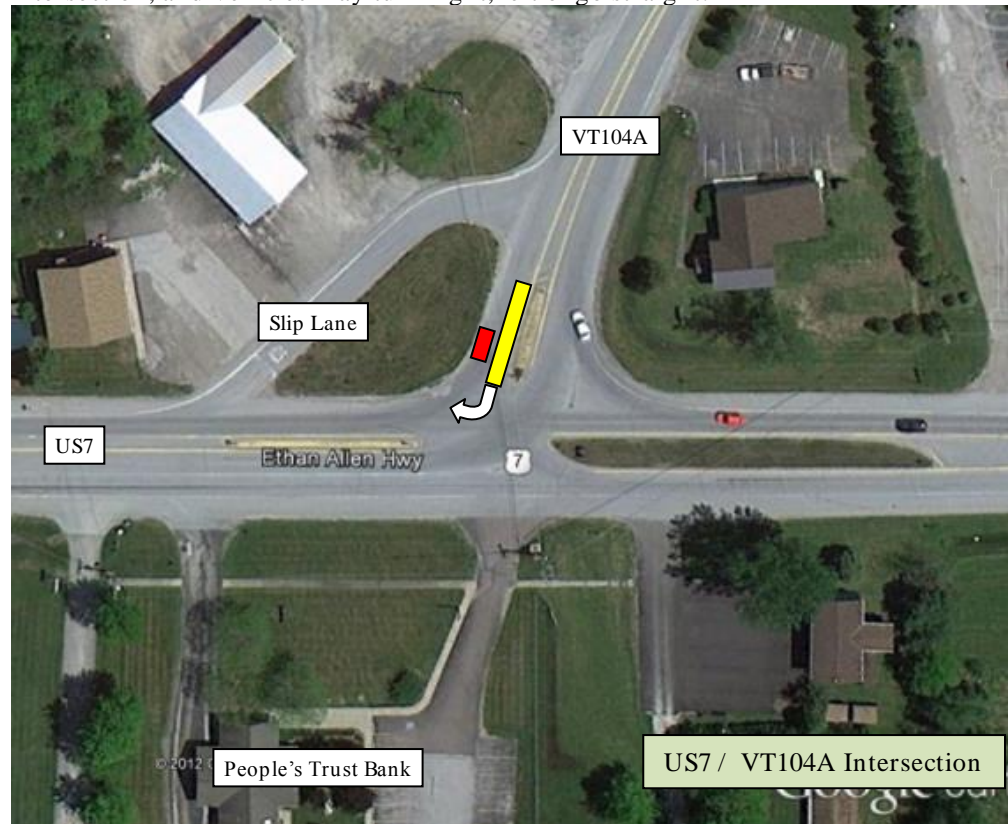
It is important to note that the westbound VT104A approach is striped as one lane, however vehicles are frequently observed forming a left and a right (and/ or a through) lane. In addition, right turning trucks are observed starting the right turn from the left side of the approach in an effort to make the right turn without the rear wheels off-tracking into the grass. This is problematic when right turning automobiles move up beside the trucks unaware that the trucks will turn right. This has resulted in crashes since the truck drivers (in yellow above) do not expect the

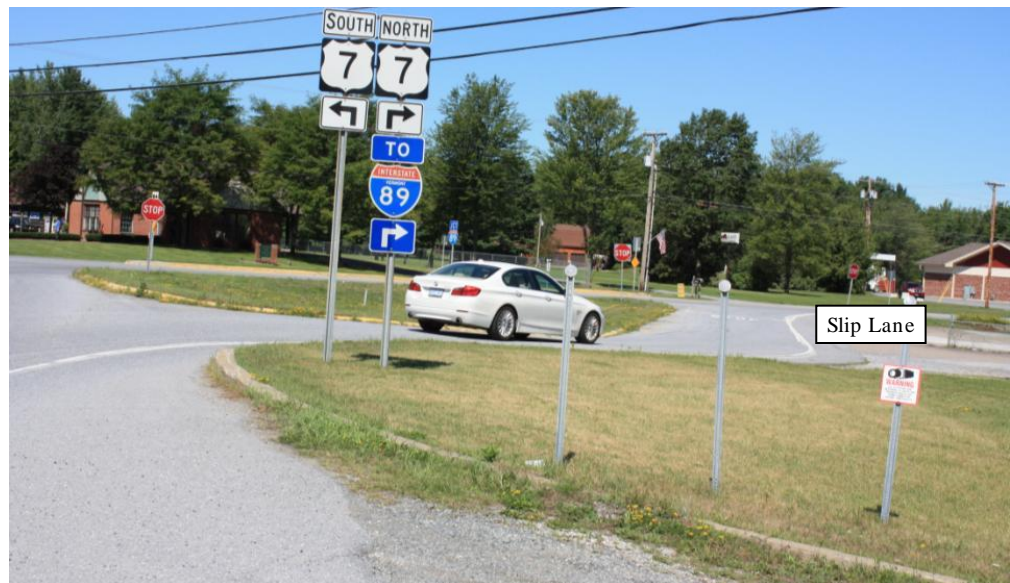
The VT104A westbound to US7 northbound slip lane is a minor concern because some motorists use it to avoid delays at the stop sign at US7. This slip lane is meant to provide access to the adjacent businesses, but it also introduces some confusion for

motorists uncertain about whether they should be using it to turn right onto US7. The re-entry point at US7 is at a very skewed angle and introduces a second potential point of conflict for vehicles on US7 in less than 100 feet. The below photo also shows that the placement of the exiting guide signs might suggest that motorists should use the slip lane to access US7, which is not the intent.

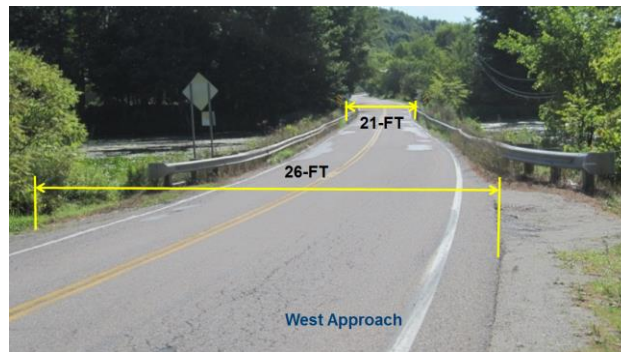
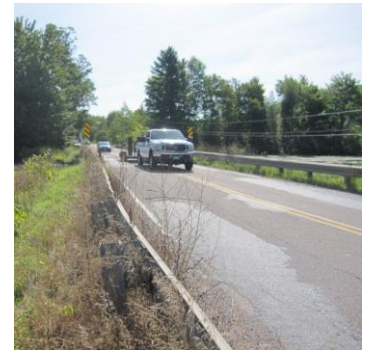
The below photos illustrate how the pavement narrows at the bridge. They also shows that both approaches are curved and the bridge is on a small crest vertical curve. Note in the left photo that vegetation is beginning to encroach on sight lines on the inside of curves.

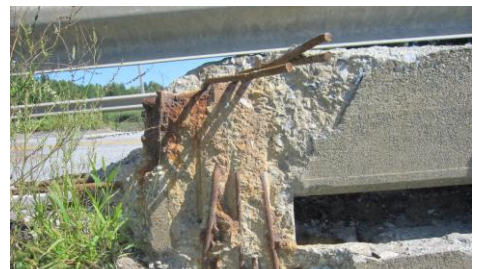
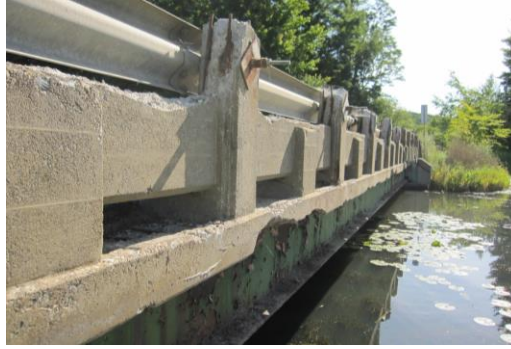
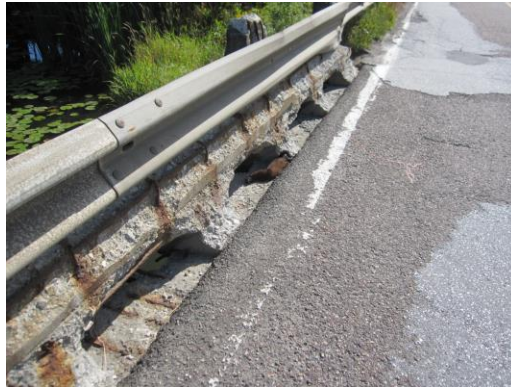
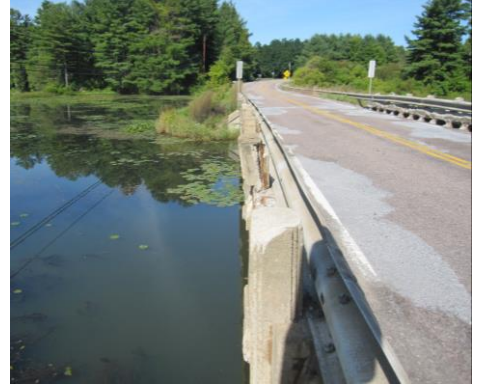
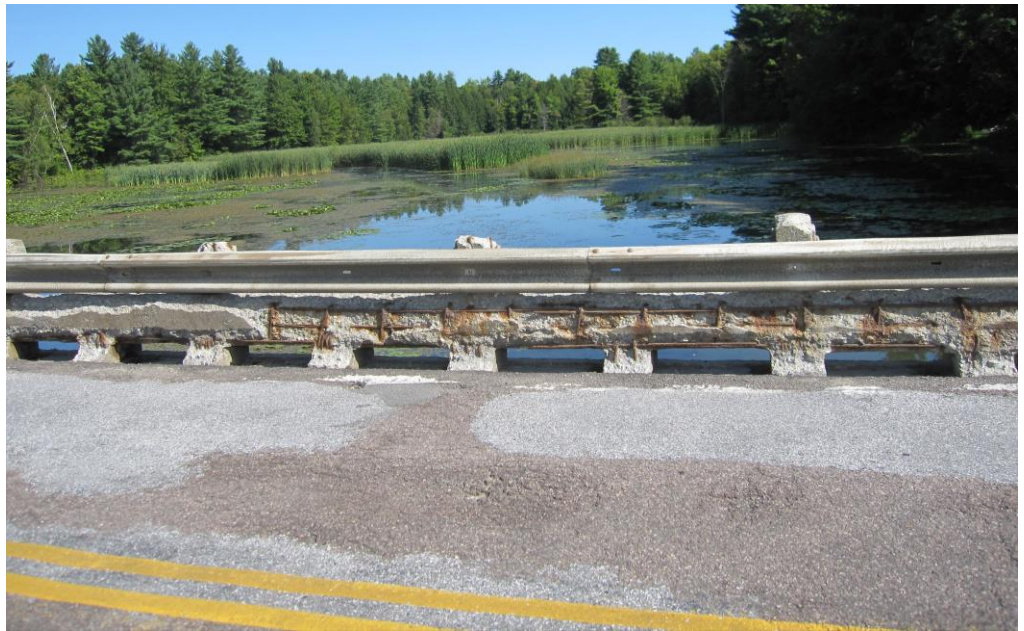
The existing bridge, built in 1937, is in satisfactory condition overall, but there is ongoing deterioration of the deck and rusting of the steel beams. The existing concrete guardrail posts are severely deteriorated and the steel beam guardrail has become detached from the posts in areas and is an immediate safety concern.

The latest VTrans bridge rating yielded a Sufficiency Rating of 72 (with a score of 100 being the best). This is not a poor enough rating for the bridge to be considered a priority by VTrans. The supporting steel members appear to be in fair condition; however the guardrail system is in poor condition and the deck appears to have areas of concern. The guardrail is of particular concern since it may not contain an errant vehicle on the narrow bridge. The existing concrete posts are in various stages of disrepair and in some locations the steel beam rails have become detached from the posts. The below photos illustrate some of the areas of concern.
